PROJECTclarity

December 2019 Dashboard

A community initiative to permanently clean and restore the waters of Lake Macatawa and the Macatawa Watershed

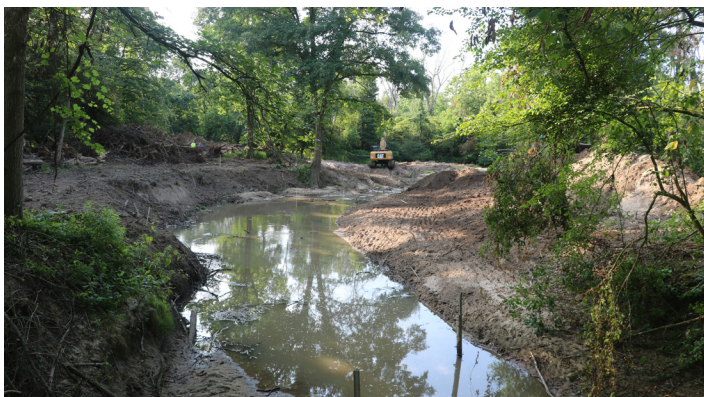
(left) Initial brush clearing and earthwork

The areas around Peters Creek in Zeeland Township have long been prone to erosive forces within the stream channel. While rivers naturally move around within their floodplains, many streams in our area move too quickly and erode the nearby streambanks. After implementing thousands of acres worth of best management practices upstream to help manage flows and sediment loading, we restored a section of Peters Creek on our Poppen Woods property, located along the Macatawa Greenway.

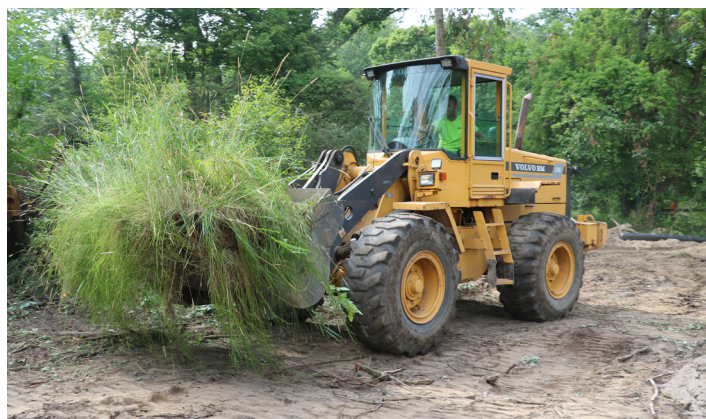
Bringing in mats of grass and shrubs to plant on top of stabilizing banks

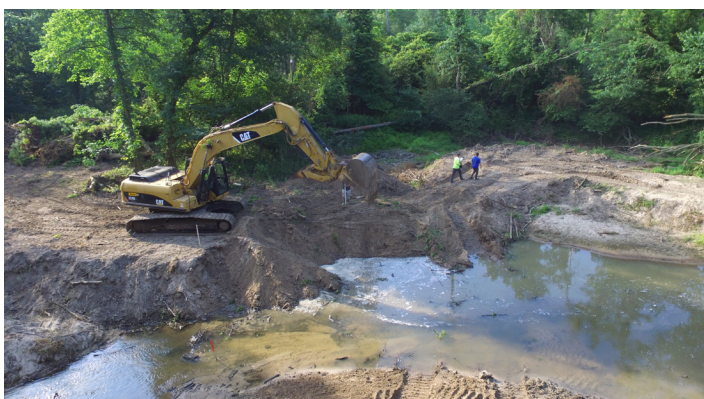
Once banks were cut, logs and brush were installed

Crews from North State Environmental (North Carolina), Green Watershed Restoration (Colorado), Niswander Environmental (Michigan), and 28 Specialties (Michigan), completed the earthmoving and initial seeding in just under a weeks' time. Using natural channel design and materials from the site, the team reshaped the channel and added log structures designed to reduce erosion and move sediment naturally through the stream. Rather than using rock to protect streams, which is often considered the cheap, effective way to protect eroding banks, the project utilized sunken logs called toe wood. This helped reduce costs of bringing in rock as well as allowed for the use of logs that were cleared to create room to work. The site later received native seed and live stakes of native shrubs to help protect the banks long term. All together, this site will prevent eleven dump trucks worth of sediment from entering the stream on a yearly basis.

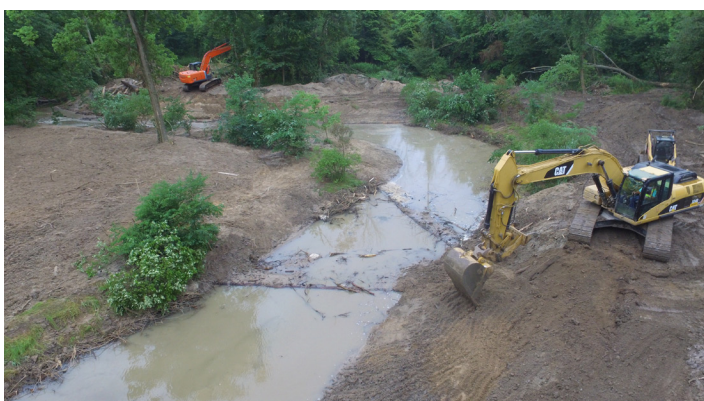
Log structures called cross veins are used to slow and direct water flow

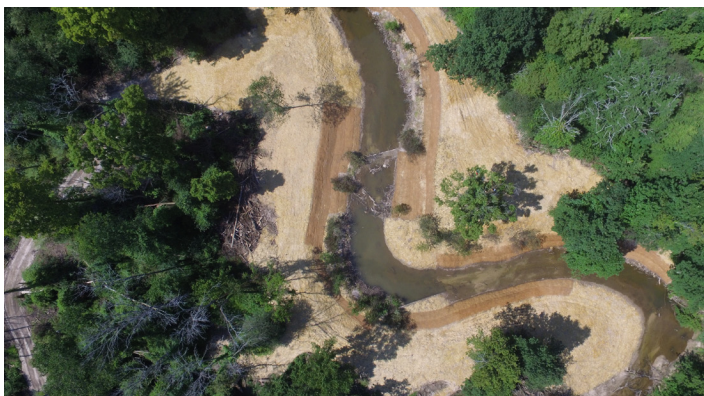
Erosion mats help control erosion while plants grow

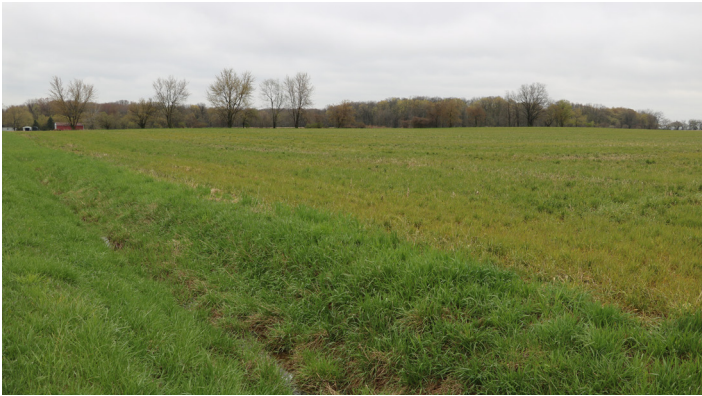
In our continuing effort to find new ways to reduce phosphorus — particularly dissolved phosphorus, the most available to algae — we have installed additional slag filters in the southern reaches of the watershed. These filters process water flowing through tile drains, binding phosphorus and filtering dirt before the water reaches nearby streams. This project has been funded by a pair of grants from the Department of Agriculture and Rural Development.

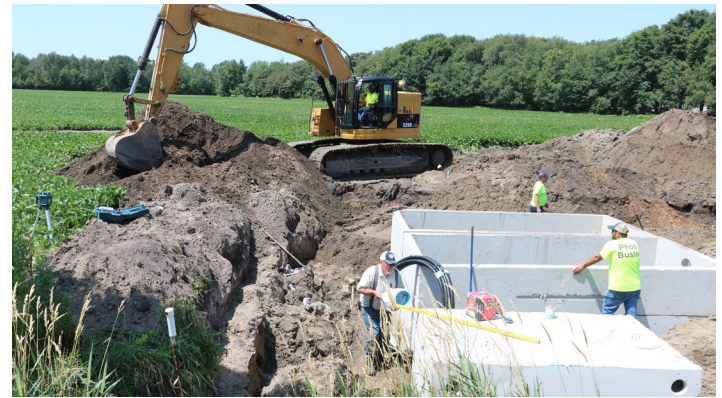
Installation of a large slag filter complex on a field in Fillmore Township
