MACATAWA WATERSHED MANAGEMENT PLAN

JUNE 2012

Macatawa Watershed Project

Macatawa Area Coordinating Council

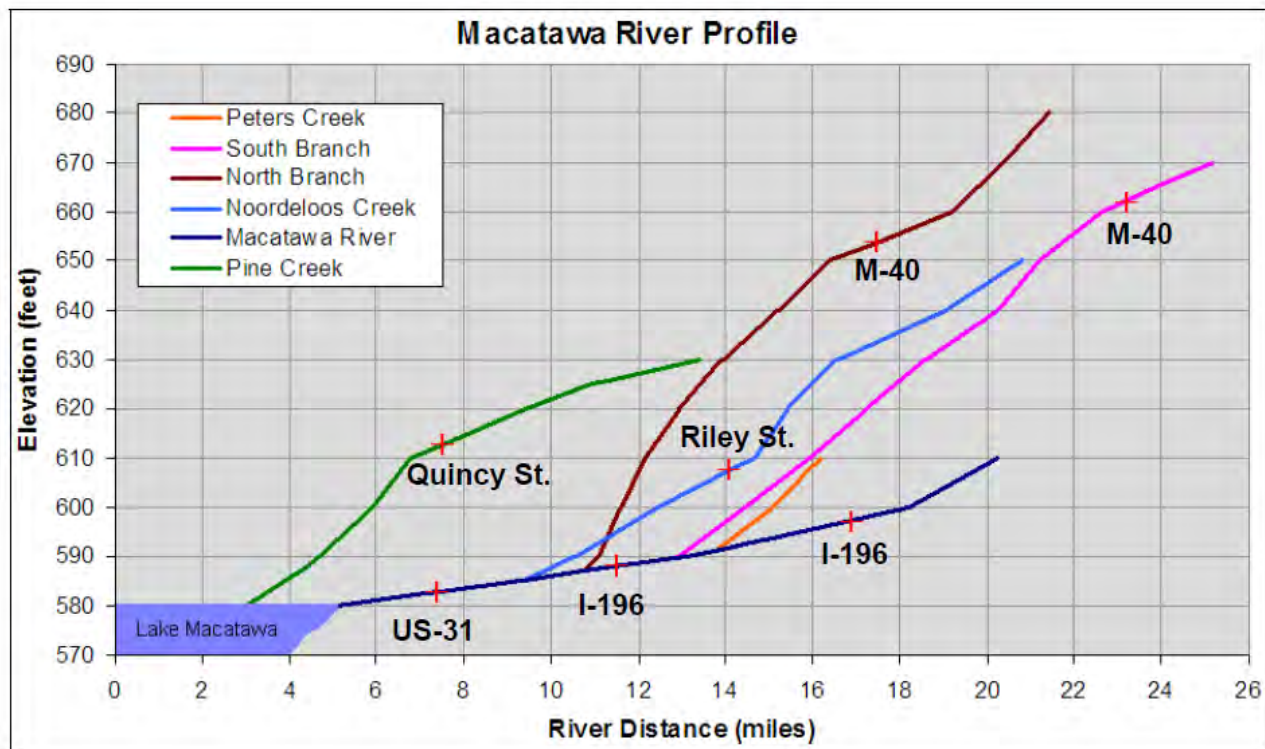
Figure 8. Profile of Lake Macatawa and its major tributaries (Source: MDEQ Macatawa Watershed Hydrologic Study, 2009, Appendix I)

A stream’s ability to move water and sediment depends on its slope. According to a hydrology study of the Macatawa Watershed conducted in 2009 by MDEQ, the Macatawa Watershed’s profile is typical, although the main branch (Macatawa River) is flatter than its tributaries (Fongers 2009, Figures 8 and 9).

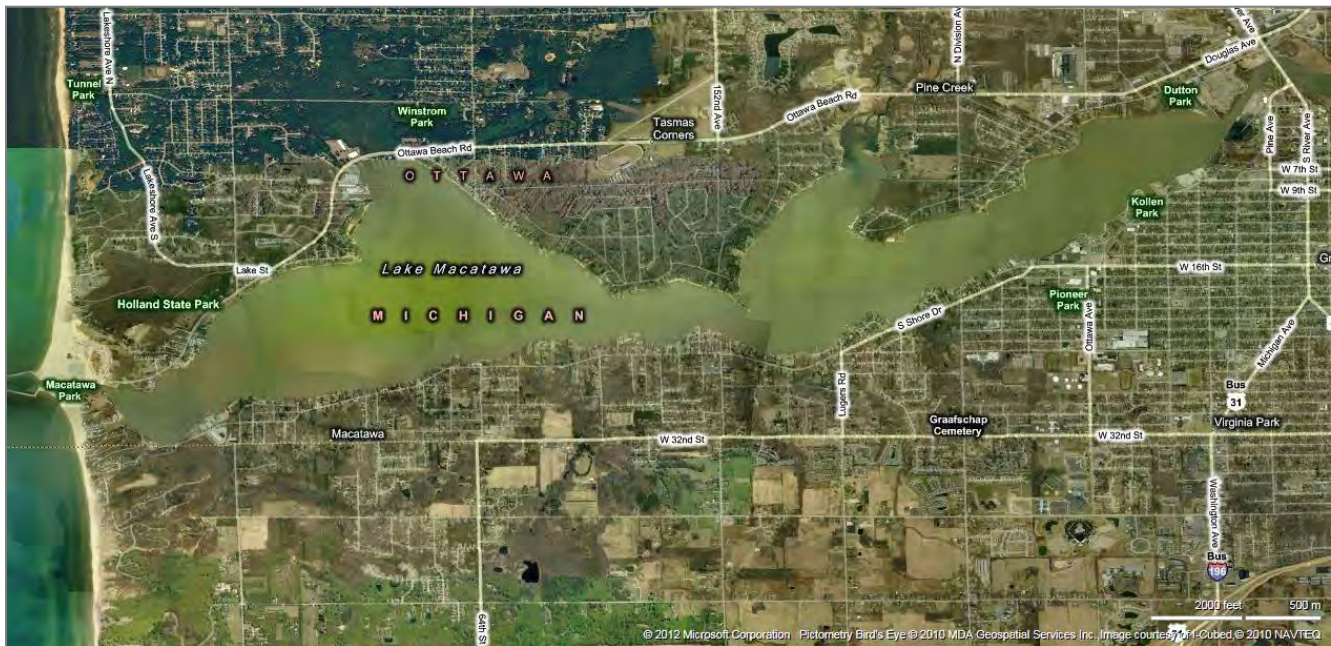
Figure 20. Aerial map of Lake Macatawa (source: Bing Maps).

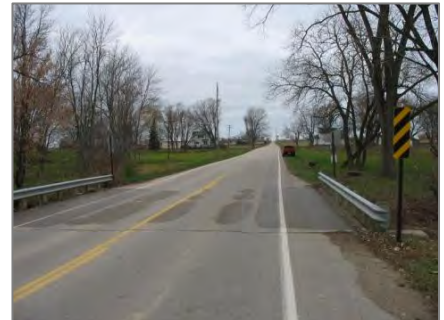
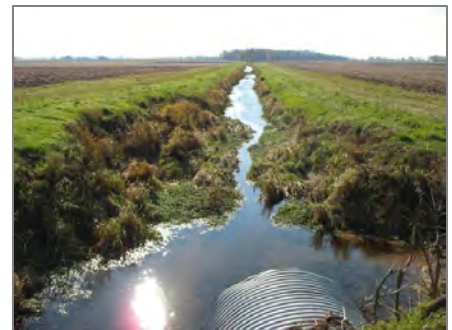
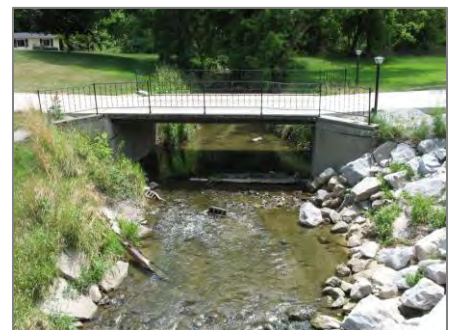
The extensive transportation system in the Macatawa Watershed results in many places where roads cross waterways, referred to as road stream crossings. According to Figure 23, there are approximately 620 such crossings throughout the Macatawa Watershed (Fales 2009). Road stream crossings are usually constructed using several different varieties of culverts or bridges and can often cause localized restriction of flow, plunge pools, disconnectedness and erosion.

Figure 23. Road stream crossings in the Macatawa Watershed.

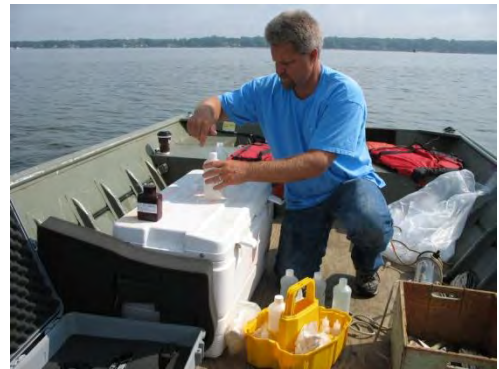
Figure 27. Historical average spring phosphorus levels in Lake Macatawa (MDEQ data, Walterhouse 2010).

The historical average spring phosphorus levels in Lake Macatawa vary widely (Figure 27). In 2010, the average spring phosphorus level was 227 parts per billion (ppb) which was lower than levels in 2008 but higher than levels in 2005 and 2006. The phosphorus levels in 2010 were 4 times greater than the TMDL goal of 50 ppb.

- Water chemistry sampling, approximately every other year, at five locations on Lake Macatawa and six locations throughout the watershed (Figure 27).
- Biological and water chemistry monitoring based on a 5-year rotating cycle (Lake Macatawa was assessed in 2005 and 2010 and we expect that monitoring will continue in 2015 and 2020). Typically monitoring occurs at 10-12 sites throughout the watershed (Table 12).

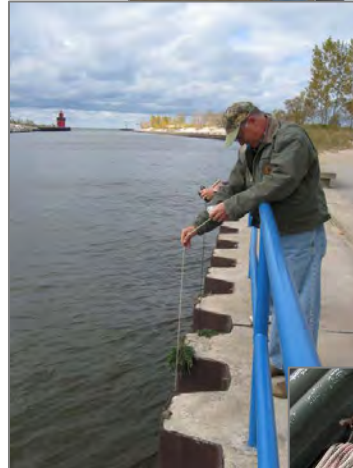
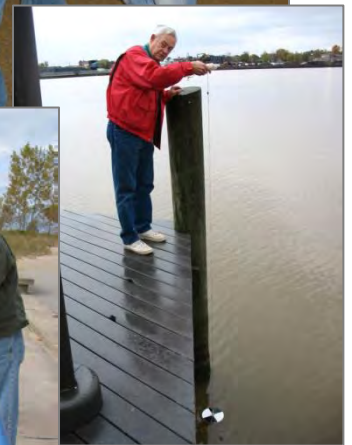
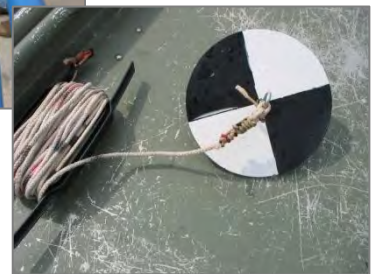
Since 2002, it appears that water clarity in Lake Macatawa, measured with the Secchi Disk, has been declining (Figure 29). In recent years, the best water clarity has occurred in the Channel connecting Lake Macatawa to Lake Michigan (4 feet of visibility). The worst water clarity has been consistently recorded at Paw Paw Park Preserve on the main branch of the Macatawa River. However, average visibility tends to be around 1 to 1.5 feet.

Figure 29. Historical Secchi Disk readings (water clarity) in Lake Macatawa based on Volunteer Monitoring Data.

Currently, the MACC organizes a volunteer monitoring program for the weekly collection of Secchi Disk depths and water temperatures at four sites throughout the watershed (Section 3.4, Figure 29). This data is crucial for assessing the impact of thermal pollution and sedimentation on Lake Macatawa.
